Name of Dam: Lake Anne Dam

Location: Fairfax County, State of Virginia

PHASE I INSPECTION REPORT.

NATIONAL DAM SAFETY PROGRAM

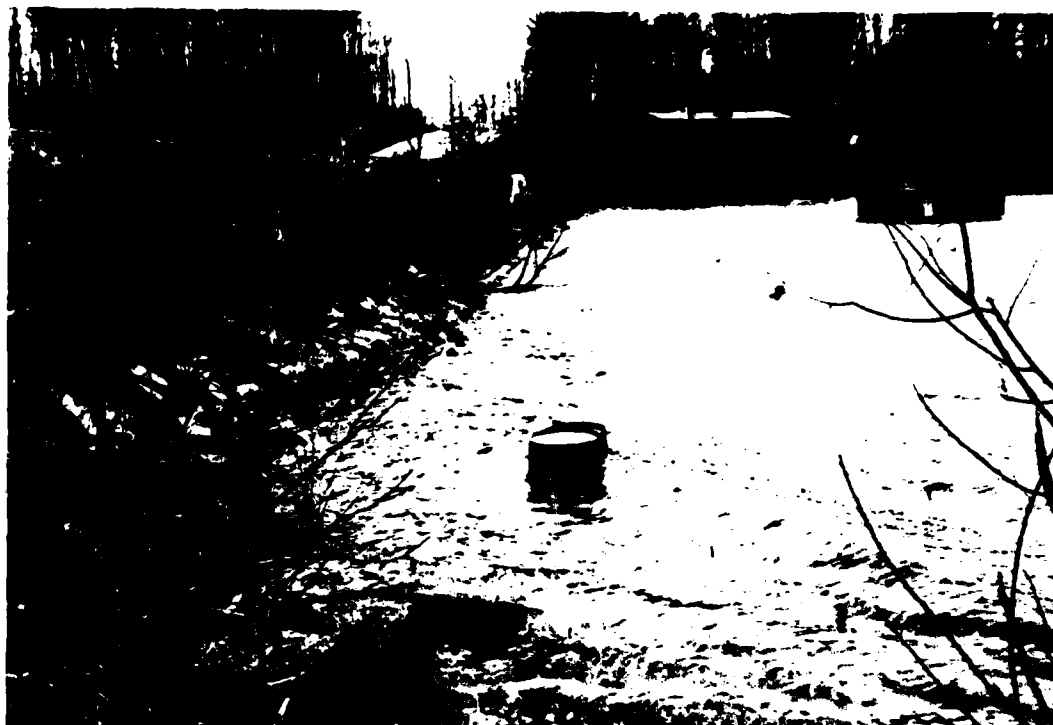
PHOTO 1. Upstream Slope from Left Abutment

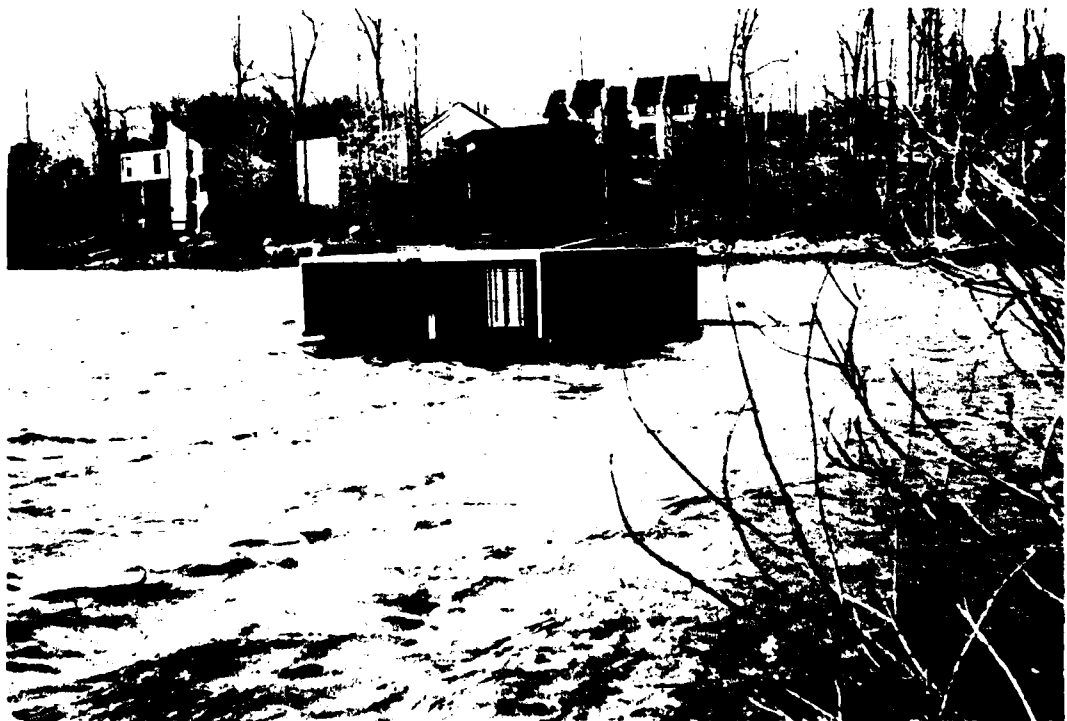
- 3.1.3 Appurtenant Structures: Severe spalling of the concrete is taking place both on the inside and outside of the left downstream corner of the spillway intake structure near the normal reservoir level. The concrete of the outlet structure appears to be in good condition with no evidence of cracking or spalling. The high tailwater at the time of inspection prevented examination of the interior of the spillway conduit and the bottom of the stilling basin. Moderate erosion has occurred on the sides of the stilling basin. Drainage from a wet area on the right side of the basin has evidently caused some of this erosion. There are two sections of metal guard rail in the downstream end of the basin and a fallen tree trunk on the right side.

PHOTO 4. Spillway Intake Structure

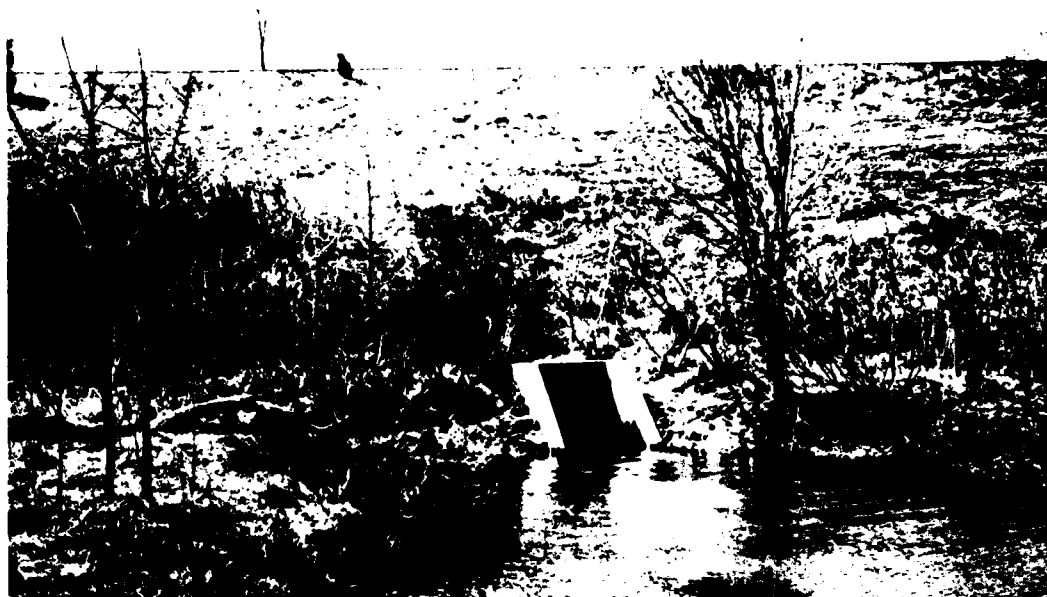
PHOTO 5. Spillway Outlet Structure and Downstream Slope
